CRUCK BUILDINGS

By B. Bunker

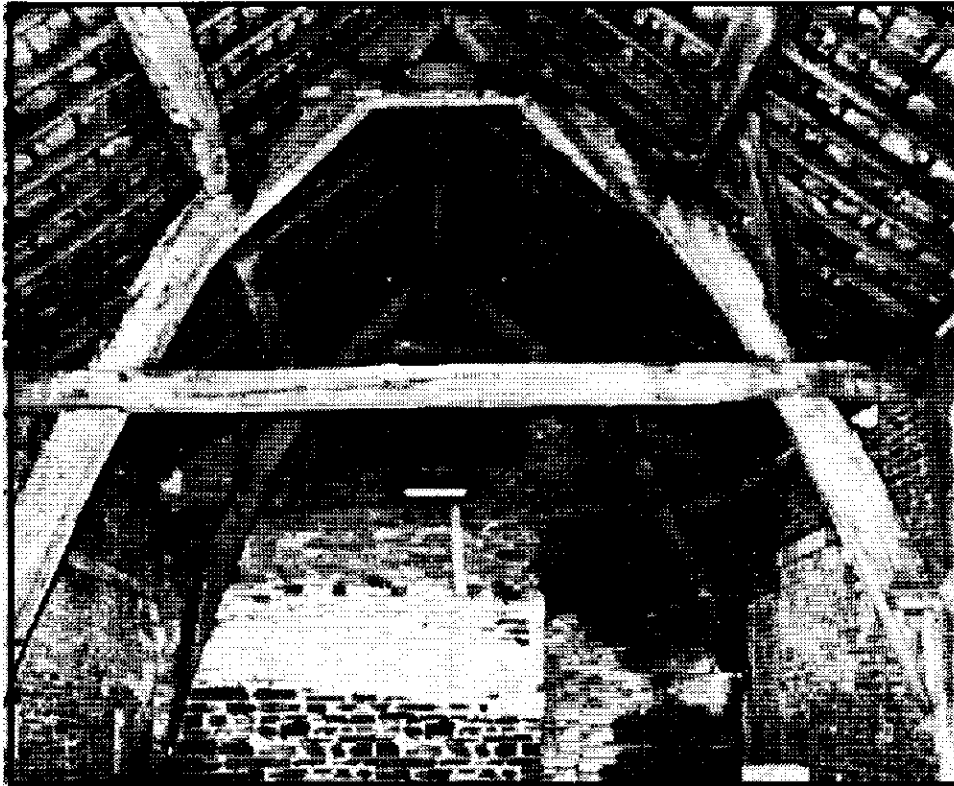
Photo showing the giant oaken "crucks" made from the natural curve of England's precious timber

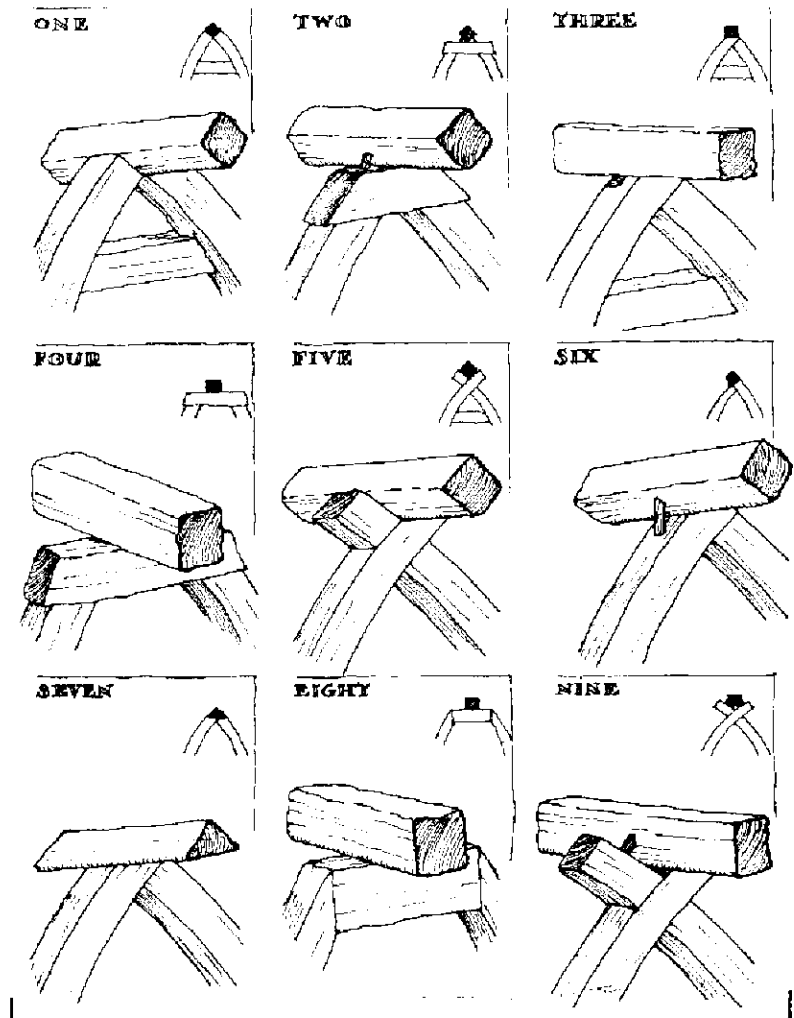
Various methods of supporting the ridge pole in cruck buildings in North Derbyshire and South Yorkshire, England (by B. Bunker)
